Dynamic Coast - National Coastal

Please reference this report as follows: Hansom, J.D., Fitton, J.M., and Rennie, A.F. (2017) Dynamic Coast - National Coastal Change Assessment: Cell 1 - St Abb's Head to Fife Ness, CRW2014/2.

Dynamic Coast - Scotland's National Coastal Change Assessment

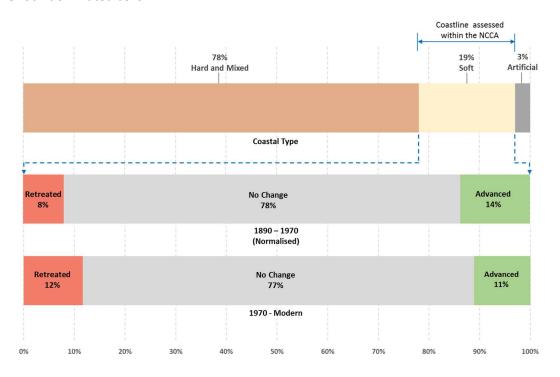
Figure 1: National coastal change results showing the proportion of soft coast retreating, stable and advancing within each change category in the historical (ca. 1890-1970 normalised for time period) and recent (ca. 1970-Present) time periods.

Since the 1970s, 12% of the soft coast length across Scotland has retreated landwards (erosion), 11% has advanced seawards (accretion) and 77% stable or has shown insignificant change (Figure 1). National comparisons from the historical period (1890 to 1970) to recent period (1970-modern), accounting for the different time periods, show an increasing proportion of erosion (8% to 12%), similar stability (from 78% to 77%) and falling accretion (14% to 11%). Where coastal changes occur, they are faster than before. Nationally, average erosion rates after the 1970s have doubled to 1.0 m/yr whilst accretion has almost doubled to 1.5 m/yr.

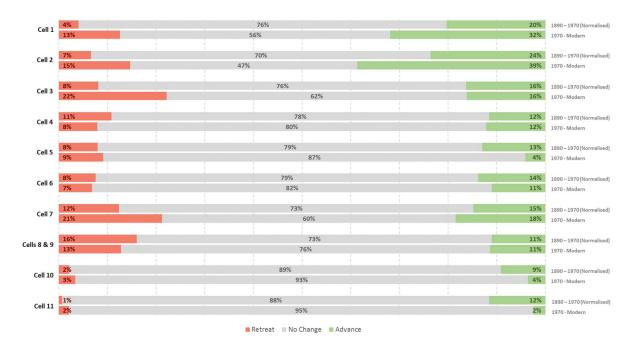
Figure 2: National coastal change results showing historical (ca. 1890-1970, normalised for time period) and recent (ca. 1970 Present.) % of coastal cell showing retreat (red), stability (grey) and advance (green) for soft coast within each cell.

The national pattern is an aggregation of different results from different parts of the country (Figure 2). The more exposed mainland east coast cells (1,2,3) and Solway Firth (7) have greater proportions of soft coast erosion and accretion (i.e. significant change) and lower proportions of stability. On the rock-dominated cells (for example cells 8,9,10, 11), soft coast stability is far higher and the extent of erosion and accretion lower. Whilst the natural level of protection offered to the soft sections of coast by the surrounding rocky coast has not changed through time, the proportion of soft coast experiencing erosion and accretion has. Considering the changes through time, the exposed coastal cells of the east coast have seen greater increases in change, with more modest changes occurring on the rock-dominated cells.

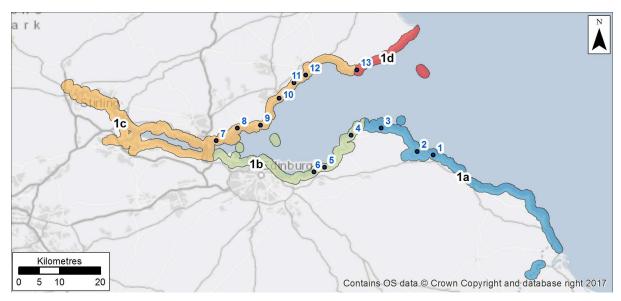
Figure 1.1: The sub-cell boundaries of Cell 1 and locations of sites discussed in this report (blue numbers).

Cell 1 extends from the English border near St Abb's Head northwards to Fife Ness including the Firth of Forth. The sub cell boundaries are shown in Figure 1.1 below. Further contextual information about the processes operating in Cell 1 can be found in Ramsay & Brampton (2000). Cell 1 benefits from the existence of Shoreline Management Plans for both East Lothian and Fife coastlines.

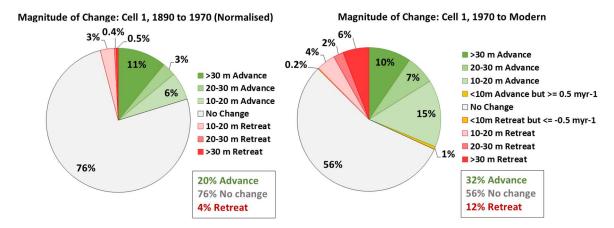
Figure 1.2: Coastal change results for Cell 1 showing the proportional amount of change in the historical (ca. 1890-1970 normalised) and recent (ca. 1970-Present) periods. Rounding errors may produce small % differences between Figure 2 and Figure 1.2.

When this adjustment is applied the extent of erosion increased from 4% historically to 13% post 1970s, the extent of stability reduced from 76% to 56% and the extent of accretion increased from 20% to 32%. In addition to the increases in the extents of erosion and accretion in Cell 1, there has been a substantial increase in the rate of erosion, with the fastest rates (30m+ over 37 years) now affecting 6% of the retreating shore, up from 0.5% historically. Accretion rates also increased although the fastest rates (30m+ over 37 years) now affect 10% of the advancing shore, a fall from 11% historically (Figure 1.2).

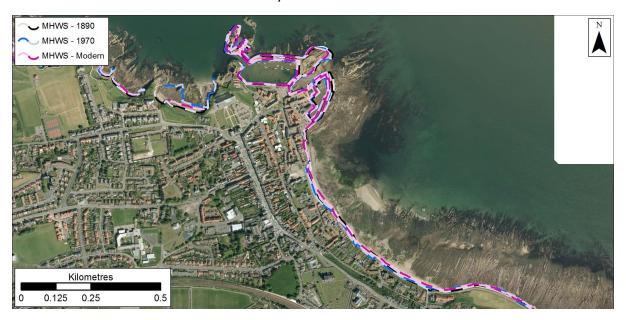
Figure 1.3: MHWS position in 1890, 1970s, and Modern datasets at Dunbar. Getmapping are our current providers of Scotland-wide digital aerial imagery© Getmapping plc.

Historical Change: Whilst much of the shoreline has remained stable, to the east of Dunbar, at the site where the Torness Power station is now located, there has been 300 m of land claim over 800 m of coast. This section of coast is now stable and protected by an artificial boulder embankment so that no change is detectable between 1970 and modern. Dunbar east beach, to the southeast of Dunbar harbour, is backed by an assortment of old masonry seawalls and has seen significant seaward movement in MHWS between 1983 and 2011 (Figure 1.3). More recently however, the beach levels were anecdotally reported by the Dunbar Beach Action Group as having dropped following storm events in winter 2013/2014. A proposal (2016) is in place to feed the beach with sediment to restore its recreational and protective potential. Immediately to the west of the harbour, the first embayment has experienced between 16 m (east end) and 48 m (west end) coastal retreat between 1983 and 2011. The rocky intertidal foreshore and high bluffs to the rear will likely limit future retreat rates. This is also the case for the coastline to the west that fronts the golf course as far as the entrance to Belhaven Bay.

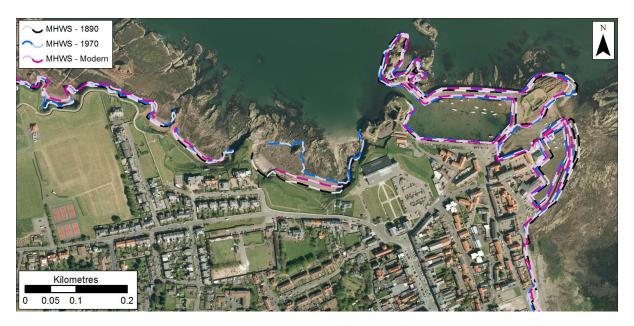
Figure 1.4: MHWS position in the 1970s, and Modern datasets at Dunbar Harbour. Getmapping are our current providers of Scotland-wide digital aerial imagery© Getmapping plc.

Future Vulnerability: The area west of Dunbar Harbour is anticipated to experience erosion by 2050 (Figure 1.4 and Figure 1.5). The assets affected are environmental (nature conservation sites in the Firth of Forth) in the first instance. Further landward and within the erosion vicinity polygon, a 90 m (0.09 km) section of road and at least three properties lie within the potentially erodible area. This location also includes a Potentially Vulnerable Areas (PVA), the Battle of Dunbar Battlefield, the Firth of Forth Special Protected Areas (SPA) and Site of Special Scientific Interest.

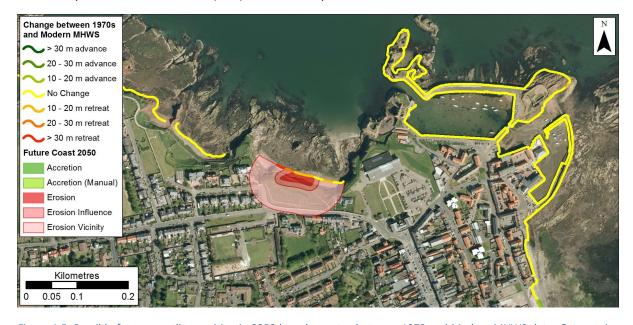
Figure 1.5: Possible future coastline position in 2050 based on rates between 1970 and Modern MHWS data. Getmapping are our current providers of Scotland-wide digital aerial imagery[©] Getmapping plc.

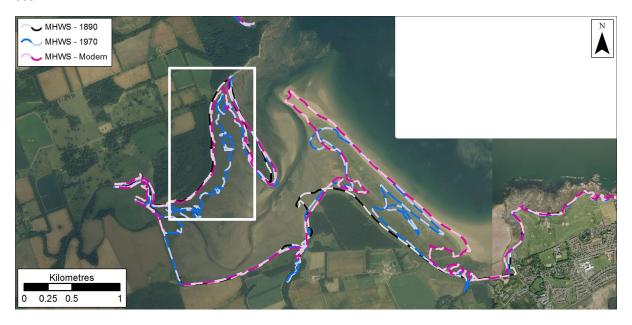
Figure 1.6: MHWS position in 1890, 1970s, and Modern datasets at John Muir Country Park. The white box delineates the area of saltmarsh referred to in the text. Getmapping are our current providers of Scotland-wide digital aerial imagery© Getmapping plc.

Historic Change: The Belhaven Bay shoreline at John Muir Country Park has seen considerable changes since the 1890s (Figure 1.6). The central section of beach, dunes and backing salt marshes have built up and extended seawards by over 350 m between 1893 and 1970 and extended

northwest by 580 m. Since 1970, the beach and dunes have continued to extend but rather than seawards they have extended alongshore towards the north east by 450 m and to the south west by 250 m. Some erosion has occurred within the River Tyne exit, most likely due to the movement of the main river channel, which in turn is in response to a modest extension of the inner spit of Sandy Hurst. The position of Sandy Hurst has not changed substantially since 1893. However, the 2011 position of MHWS on the salt marshes on the northern shore (area within the white box in Figure 1.6) appears to coincide with the position plotted in 1893. In the 1970s, it is depicted as being located some 160 m to the southeast (seaward) of the 1893 and 2011 position. Such a major retreat of MHWS across the salt marsh contrasts with the apparent extent of marsh shown on aerial imagery and it is likely that the method of survey of the saltmarsh edge differs from that used in 1893 and that used now. As a result, the 1970 position is subject to some doubt and this point is discussed in the National Overview Report. This location also includes the Firth of Forth SPA and SSSI.

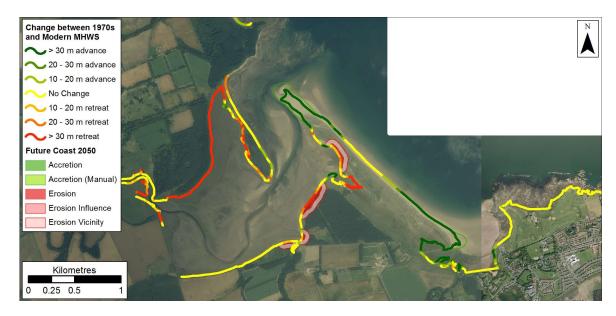
Figure 1.7: The change between the 1970s and Modern MHWS position, and the future coastal position extrapolated to 2050 in John Muir Country Park. Getmapping are our current providers of Scotland-wide digital aerial imagery© Getmapping plc.

Future Vulnerability: The Vulnerability Assessment anticipates that past accretion will continue, extending the beach and dunes to the north and south (as well as building in height) rather than seawards to the north (Figure 1.7). If past erosion trends continue within the Tyne estuary then substantial lengths of both the south and north estuary shores, including areas of beach, dune and salt marsh, may be affected by 2050 since the topography is low lying and composed of sandy sediments. The assets within this area are mainly natural heritage sites and their loss may increase the areas of flood risk. One limit to the northwards extension of future erosion vulnerability into the rear of the outer spit is that this area is also likely to accrete and gain in height from sand feed along the outer coast. The integrity of this section of the spit will depend on the relative balance of sand loss on the inner face versus sand gain on the outer face.

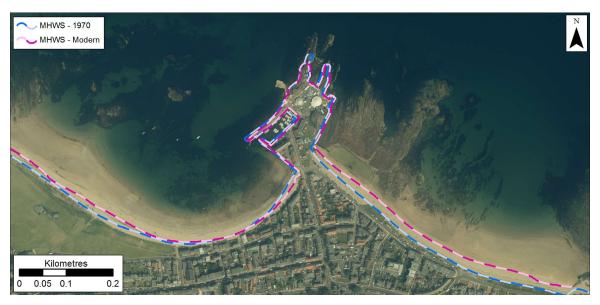
Figure 1.8: MHWS position in the 1970s, and Modern datasets at North Berwick. Getmapping are our current providers of Scotland-wide digital aerial imagery© Getmapping plc.

Historic Change: To the east of the harbour along the seafront of North Berwick, the position of MHWS has either remained stable or shown minor advance between 1893 and 1992 although the 8 m of advance is below the threshold (10 m) of significant change. Between 1992 and 2011 there has been seaward advance of some 18 m (i.e. 0.9 m/yr) along much of the eastern beachfront. To the west of the harbour, between 1890 and 1970 the shoreline remained largely stable although immediately to the south of the harbour the beach advanced some 9m (0.1 m/yr). This trend was reversed between 1991 and 2011 with 12 m (0.5 m/yr) of erosion occurring immediately south of the harbour wall and 15m of accretion at the western end of the beach (0.6 m/yr) (Figure 1.8). The foreshore at North Berwick is designated as part of the Firth of Forth SPA and SSSI.

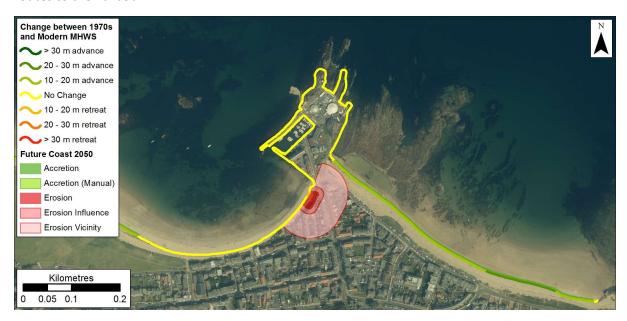
Figure 1.9: Possible future coastline position in 2050 based on rates between 1970 and Modern MHWS data at North Berwick. Getmapping are our current providers of Scotland-wide digital aerial imagery© Getmapping plc.

Future Vulnerability: The Vulnerability Assessment used the current erosion and accretion rates and projects them forward to 2050. Since much of the beachfront either side of the harbour shows accretion then these are predicted to continue to 2050 and are depicted via the green accretion area bars on Figure 1.9. However, in the area immediately adjacent and south of the harbour the predicted erosion by 2050 area impinges on one building with the erosion influenced area capturing a further four buildings and residences. The area of erosion vicinity includes a further 34 buildings and residences as well as significant length of Victoria Road and Melbourne Road, the only access routes to the harbour.

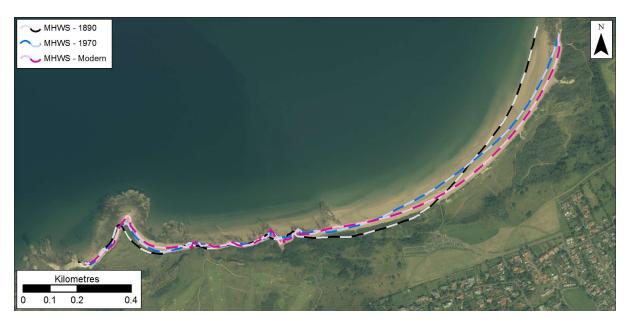
Figure 1.10: MHWS position in 1890, 1970s, and Modern datasets at Gullane Bay. Getmapping are our current providers of Scotland-wide digital aerial imagery© Getmapping plc.

Historic Change: Much of the shoreline east of Gullane is characterised by cliffs with pocket or cliff-foot beaches that have remained stable or have shown minor accretion between 1890, 1970 and modern (Figure 1.10). A minor amount of erosion has occurred between 1970 and modern at the western edge of a north-east facing beach to the north of Muirfield Golf Course and west of Dirleton. At Gullane, the beach has undergone a substantial amount of reshaping between 1890 and modern with erosion of 40 m (1890-1970) and up to 35 m (1970-modern) at the northern and central sections, and accretion of 25 m (1890-1970) and 15 m (1970-modern) in the western end. The accretion trend continues toward the headland to the west but at much reduced amounts.

Further west, substantial accretion dominates within Aberlady Bay, particularly on the eastern side where 100 m accreted between 1980 -1970 (ca 1 m/yr) and a further 330 m 1990-2011 (ca 15 m/yr). The south side of the bay has seen only minor accretion or stability over the same time spans as above. Aberlady Bay is part of the Firth of Forth SPA.

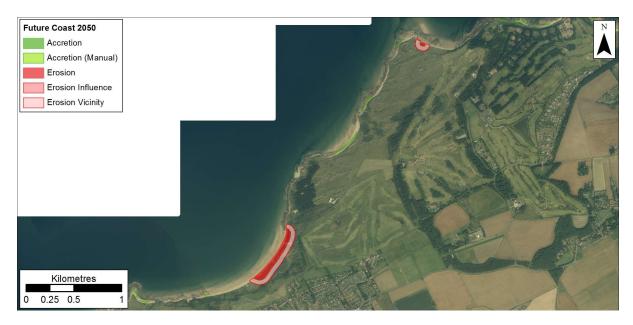
Figure 1.11: Possible future coastline position in 2050 based on rates between 1970 and Modern MHWS data at Gullane Bay. Getmapping are our current providers of Scotland-wide digital aerial imagery© Getmapping plc.

Future Vulnerability: The Vulnerability Assessment used the current erosion and accretion rates and projects them forward to 2050. Because of past erosional trends in the northern part of Gullane beach, the future look of vulnerability depicts a significant length of shoreline (600 m) to be potentially erosion-affected by 2050, with the erosion zone extending 50 m inland and the erosion influenced zone at 60 m inland (Figure 1.11). There are no built assets within this zone with the nearest residential properties a further 200 m inland and situated on top of a cliffline.

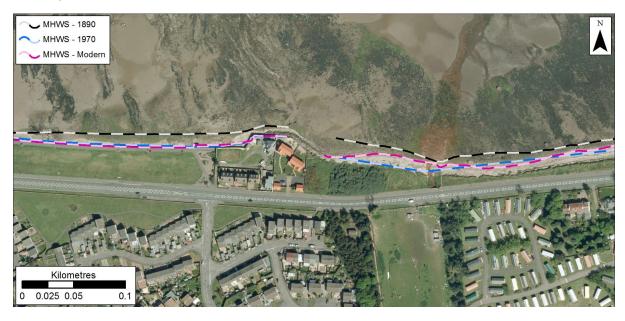
Figure 1.12: MHWS position in 1890, 1970s, and Modern datasets at Port Seton. Getmapping are our current providers of Scotland-wide digital aerial imagery© Getmapping plc.

Future Vulnerability: Much of the foreshore at Port Seton has a veneer of sediments partially covering a rocky foreshore. The shoreline has retreated between 1890 and 1970, however to the eastern half of Figure 1.12, recent advances can be seen of up to 17 m and up to 12 m towards the west. There is little recent change adjacent and to the west of the coast protection in front of a small collection of buildings in the middle of the map. Such a location would not normally merit inclusion; however aerial photography clearly shows the undermining of a grassed area landward of the seawall. So, whilst no damage is known to have occurred to property, this demonstrates the fallibility of seawalls in some situations.

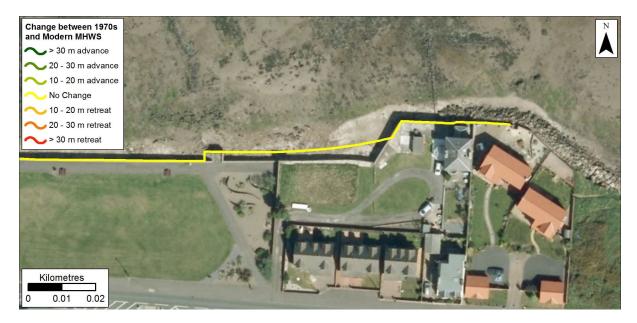
Figure 1.13: Aerial photography from 2009-05-11 showing the initial situation, with the grassed area behind seawall unaffected, see Figure 1.14 for comparison. Getmapping are our current providers of Scotland-wide digital aerial imagery© Getmapping plc.

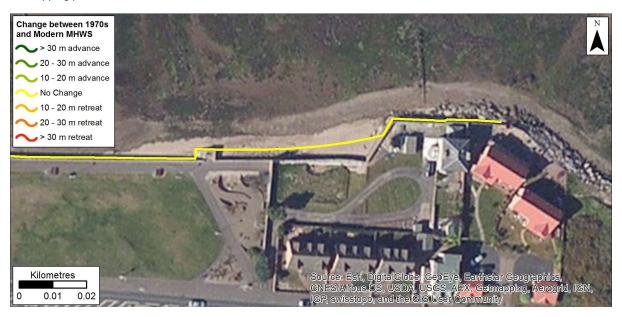
Figure 1.14: Esri default air photography taken on 2011-05-01 showing an area of undermining landward of the sea wall, see Figure 1.13 for comparison.

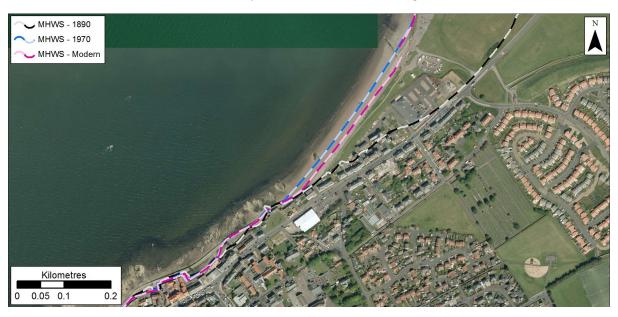
Figure 1.15: MHWS position in 1890, 1970s, and Modern datasets at Prestonpans. Getmapping are our current providers of Scotland-wide digital aerial imagery® Getmapping plc.

Historic Change: Much of the shoreline between Cockenzie and Prestonpans has either accreted or been subject to land claim after 1890 to house Cockenzie Power Station (Figure 1.15) and so the shoreline has since been protected with hard defences over much of its length. The one exception to this is along the urban frontage of Prestonpans itself where a 450m section of the beach is unprotected and has undergone erosion of ca 14m along its length between 1970 and modern. The western part of the town is protected by various generations of sea wall but beyond that the shore is unprotected north of Musselburgh Golf Course (Figure 1.16). It is possible that the coastline here once had coastal defences but these have now failed and bypassed. The shoreline is substantially seawards of the 1890 position suggesting land claim. However, there has been landward movement

of MHWS between 1970 and modern of 15-25 m along the northern shore and accretion of up to 50m on the west facing shore. Prestonpans is a Potentially Vulnerable Area, is home to the Battle of Pinkie Battlefield and the Firth of Forth Special Protection Area along its foreshore.

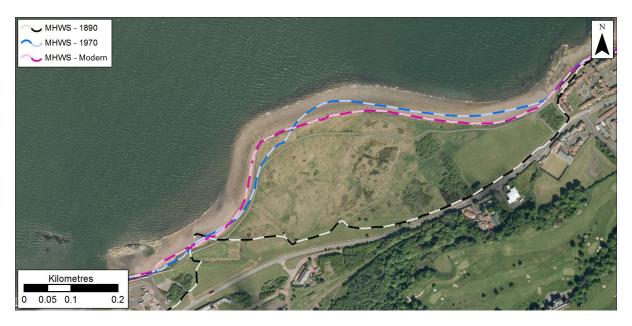
Figure 1.16: MHWS position in 1890, 1970s, and Modern datasets at east of Prestonpans. Getmapping are our current providers of Scotland-wide digital aerial imagery© Getmapping plc.

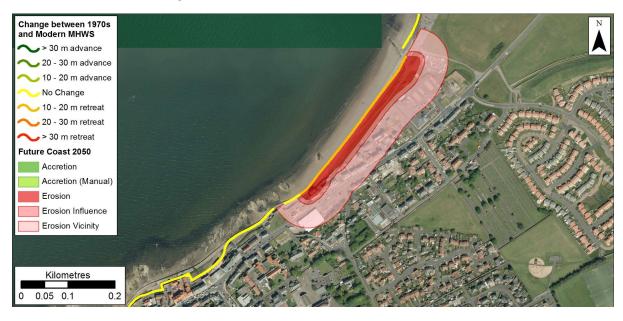
Figure 1.17: Possible future coastline position in 2050 based on rates between 1970 and Modern MHWS data in Prestonpans. Getmapping are our current providers of Scotland-wide digital aerial imagery© Getmapping plc.

Future Vulnerability: The Vulnerability Assessment used the current erosion and accretion rates and projects them forward to 2050. At the present rate of erosion of the unprotected shoreline at Musselburgh, the future area of vulnerability (Figure 1.17) spans 380 m of linear coast and extends 23 m inland affecting three commercial properties and one residential property. The erosion influenced area captures another four properties whilst the vicinity influences a further 21 properties, the High Street and an electricity substation. To the west of Musselburgh, future

erosional vulnerability affects 500 m of linear shore and extends 25 m inland. This erosion affected area is mainly undeveloped land, though the erosion vicinity does impinge on a short stretch of the western extension of the High Street.

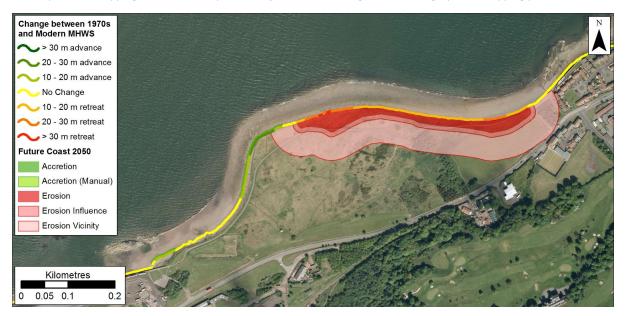
Figure 1.18: Possible future coastline position in 2050 based on rates between 1970 and Modern MHWS data east of Prestonpans. Getmapping are our current providers of Scotland-wide digital aerial imagery© Getmapping plc.

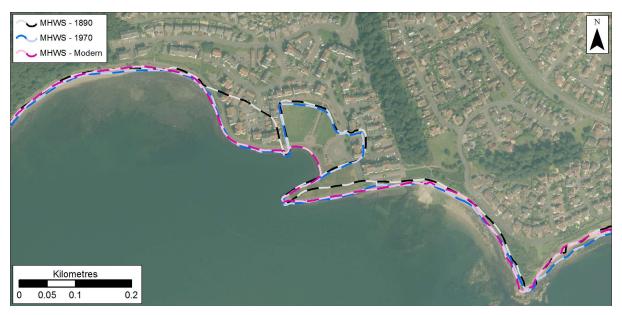
Figure 1.19: MHWS position in 1890, 1970s, and Modern datasets at Dalgety Bay. Getmapping are our current providers of Scotland-wide digital aerial imagery© Getmapping plc.

Historic Change: The coastline at Dalgety Bay is now mostly protected or is rocky along its length and shows only minor fluctuations in the positions of MHWS over time (1890-modern). The one exception occurs at Harbour Place where the 1890 and 1970 shore positions show an inlet that once may have been a small harbour. The modern shore shows this inlet to have been removed, probably the subject of land claim post 1970 and the shoreline is now artificially protected. The foreshore at Dalgety Bay is part of the Firth of Forth Special Protection Area.

Future Vulnerability: The Vulnerability Assessment used the current erosion and accretion rates and projects them forward to 2050. No issues of past significant erosion are noted at Dalgety Bay and so the future vulnerability map shows no areas of concern.

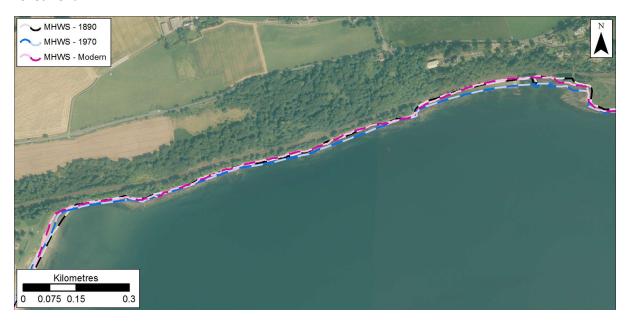
Figure 1.20: MHWS position in 1890, 1970s, and Modern datasets at Aberdour and Burntisland. Getmapping are our current providers of Scotland-wide digital aerial imagery© Getmapping plc.

Historic Change: The coastline between Aberdour and Burntisland is backed by a rock cliff that falls to a low platform along which the rail line to Kirkcaldy runs. Between 1970 and modern, the shoreline has receded by 10-20 m with most erosion occurring in the east. Similar amounts of erosion have occurred in the past in the west but this section is now protected by a boulder revetment.

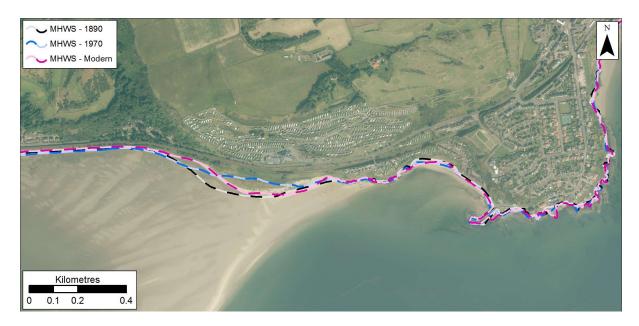
Figure 1.21: MHWS position in 1890, 1970s, and Modern datasets at Kinghorn. Getmapping are our current providers of Scotland-wide digital aerial imagery© Getmapping plc.

Historic Change: To the west of Kinghorn the coast has shown minor erosion of up to 10m between 1970 and modern along the length of coast where the rail line runs, although the 1890 MHWS now coincides with the modern line. East of this there has been significant accretion beyond the end of the boulder revetment that protects the rail line. However, at the end of the revetment some 24m of erosion has occurred (1970-modern) that will continue unless the revetment is extended. East of this at Kinghorn itself, between 1970 and modern there has been 12 m of erosion over 120 m of the eastern end of Pettycur Bay. Accretion has characterised the western end of the bay. The foreshore at Kinghorn is notified as a part of the Firth of Forth Special Protection Area and a Site of Special Scientific Interest.

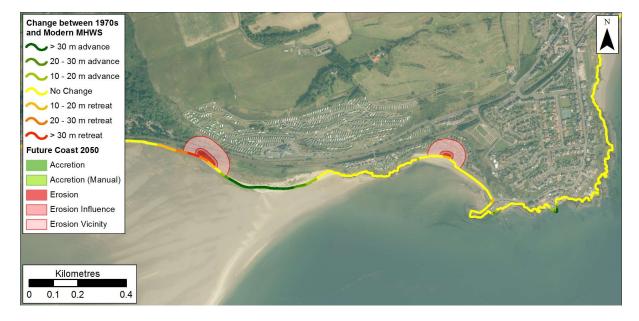
Figure 1.22: Possible future coastline position in 2050 based on rates between 1970 and Modern MHWS data at Kinghorn. Getmapping are our current providers of Scotland-wide digital aerial imagery© Getmapping plc.

Future Vulnerability: The Vulnerability Assessment used the current erosion and accretion rates and projects them forward to 2050. In the west, the area of erosion impacts mainly beach and dune but the erosion influenced area captures 30 m of rail line with a further 50 m within the erosion vicinity footprint. Moving east to Pettycur Bay, a continuation of the erosion trend produces erosion of the beach and dune area over 30m at the eastern end of the bay and with the erosion vicinity impinging on 16 residential properties and their suburban access road.

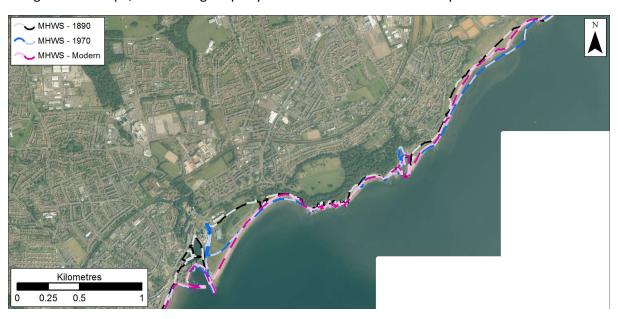
Figure 1.23: MHWS position in 1890, 1970s, and Modern datasets at Dysart. Getmapping are our current providers of Scotland-wide digital aerial imagery© Getmapping plc.

Historic Change: The shoreline at Ravenscraig Park underwent significant accretion between 1890 and 1970 that was substantially reversed from 1970 to modern so that some 39 m has been eroded from the centre of the bay with the mean erosion being 15 m or so. The east limit of the bay is

constrained by a rocky shore and so minimal change has occurred over these time frames. To the north of the park at Howard Place, The Walk and Edington Place, the shoreline has moved seaward substantially (by up to 130 m) from its 1890 position to 1970, very likely resulting from coal waste being tipped onto the foreshore, as was the practice from nearby collieries. Between 1970 and modern this has reversed with up to 90m of erosion in places, although the average amount is lower. This is the likely outcome of the cessation of colliery waste tipping and the closure of the Fife collieries post 1970. There is a Potentially Vulnerable Area at Dysart, the Dysart House Garden of Designed Landscape, Ravenscraig Property in Care and the Firth of Forth Special Protection Area.

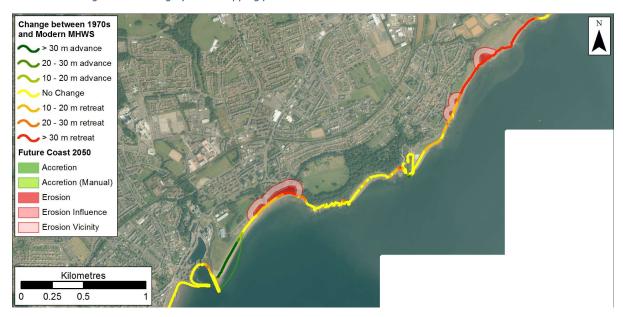
Figure 1.24: Possible future coastline position in 2050 based on rates between 1970 and Modern MHWS data in Dysart. Getmapping are our current providers of Scotland-wide digital aerial imagery® Getmapping plc.

Future Vulnerability: The Vulnerability Assessment used the current erosion and accretion rates and projects them forward to 2050. At Ravenscraig Park the future erosion vulnerability footprint largely affects beach and parkland but within the vicinity of erosion area lie six residential properties, part

of the Kyles Road and a small section of the A955 (Figure 1.24). To the north of this section lie two areas of future vulnerability. The southernmost of which affects a section of Howard Place and The Walk and includes eight residential properties within the erosion vicinity footprint. The northern area lies close to Edington Place affecting 100 m of shore and 50 m inland but no properties at risk. It is likely that this area is made ground composed of coal waste.

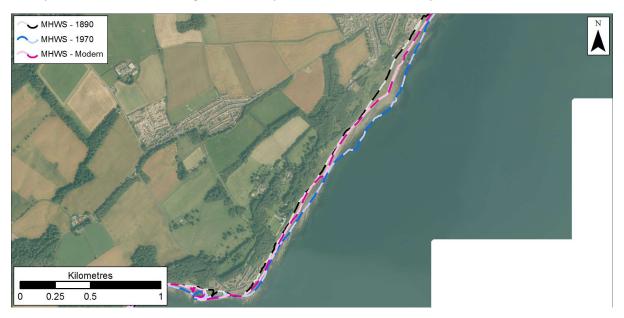
Figure 1.25: MHWS position in 1890, 1970s, and Modern datasets at West Wemyss. Getmapping are our current providers of Scotland-wide digital aerial imagery© Getmapping plc.

Historic Change: Substantial amounts of accretion occurred along this stretch of coast as a direct result of colliery waste tipping directly onto the intertidal zone at Buckhaven to the north. Up to 86 m of coastal advance occurred at West Wemyss (Figure 1.25) and 50 m at East Wemyss (Figure 1.26). This was reversed following the closure of the Francis Mine in Buckhaven with rapid erosion following between 1970 and modern, necessitating the construction of coastal defences at East Wemyss to protect houses built on the ground gained earlier. Up to 86 m has been lost at West Wemyss along substantial stretches of coast, with 16 m of loss at East Wemyss, increasing to 50 m in the north toward Buckhaven. There is a Potentially Vulnerable Area along this coastline along with Wemyss Castle Garden of Designed Landscape and the Firth of Forth Special Protection Area.

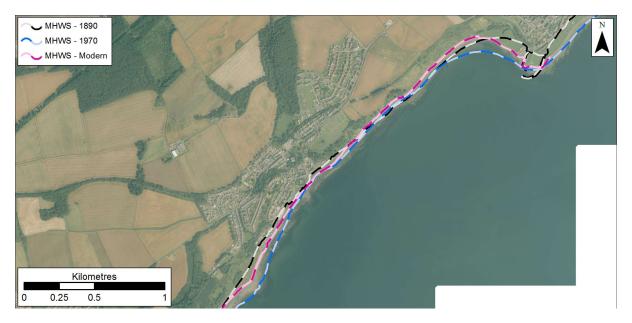
Figure 1.26: MHWS position in 1890, 1970s, and Modern datasets at East Wemyss. Getmapping are our current providers of Scotland-wide digital aerial imagery© Getmapping plc.

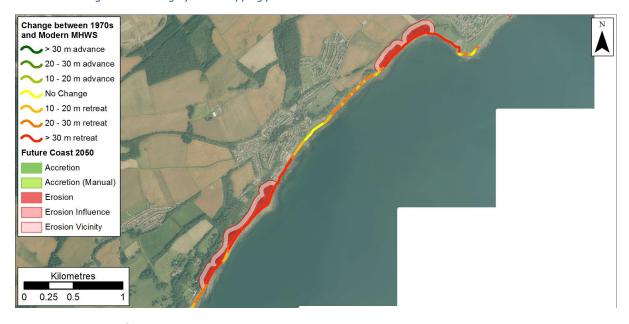
Figure 1.27: Possible future coastline position in 2050 based on rates between 1970 and Modern MHWS data at East Wemyss. Getmapping are our current providers of Scotland-wide digital aerial imagery© Getmapping plc.

Future Vulnerability: The Vulnerability Assessment used the current erosion and accretion rates and projects them forward to 2050. Much of the rapidly eroding area that starts at the south end of East Wemyss (at Back Dykes road) affects undeveloped ground characterised by bluffs of easily eroded glacial till (Figure 1.27), although one non-residential property lies within the erosion vicinity area. Since the frontage of East Wemyss itself is now protected by a boulder revetment, there are no extant future vulnerability issues noted. The area to the north and closer to Buckhaven has a 600 m long erosion footprint that affects mainly undeveloped land.

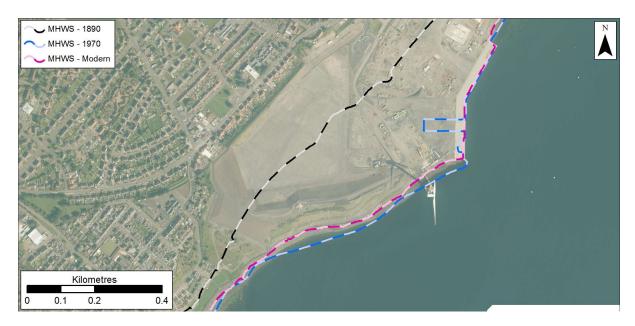
Figure 1.28: MHWS position in 1890, 1970s, and Modern datasets at Buckhaven. Getmapping are our current providers of Scotland-wide digital aerial imagery© Getmapping plc.

Historic Change: Although protected by hard defences to the limit of the developed and built up area of Buckhaven at Lady Wynd, the shoreline north of this point has shown considerable change since 1890 resulting from up to 300 m of accretion associated with land claim and colliery waste. Between 1970 and modern this has reversed by up to 50 m of erosion over 100 m in the central area north of Lady Wynd (Figure 1.28). The total area affected by erosion is about 650 m of coast. This shoreline is a Potentially Vulnerable Area and part of the Firth of Forth Special Protection Area.

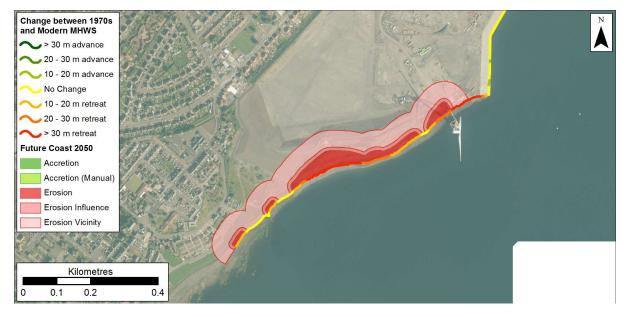
Figure 1.29: Possible future coastline position in 2050 based on rates between 1970 and Modern MHWS at Buckhaven. Getmapping are our current providers of Scotland-wide digital aerial imagery© Getmapping plc.

Future Vulnerability: The Vulnerability Assessment used the current erosion and accretion rates and projects them forward to 2050. Some 650 m of coast is vulnerable but much of this in the north affects made ground (Figure 1.29), likely of colliery waste. In the south however, at Shore Street and Lady Wynd, some 50 m of shore is vulnerable with the footprint of erosion vulnerability extending 100 m inland and affecting 11 residential properties and an electricity substation as well as some 130 m of Shore Street roadway.

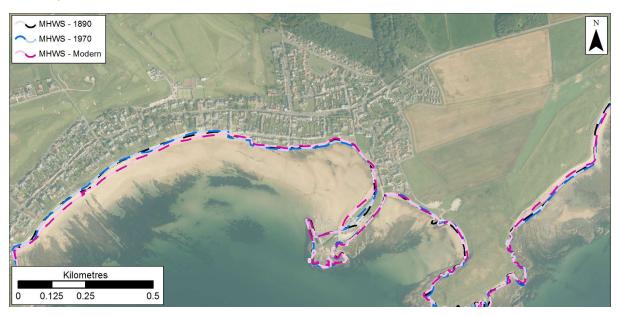
Figure 1.30: MHWS position in 1890, 1970s, and Modern datasets at Earlsferry. Getmapping are our current providers of Scotland-wide digital aerial imagery© Getmapping plc.

Historic Change: At Elie the accretion that occurred between 1890 and 1970 was reversed from 1970 to modern and the MHWS line migrated landward to reoccupy its 1890 position. Since then much of the shoreline has been subject to various protection measures that have halted any further

landward excursion, other than a very small area of shore at The Terrace where some 10 m has been lost since 1970. To the east of Elie, the beach and dune frontage has moved landward by up to 20 m over much of the foreshore between 1970 and modern, a trend that has accelerated since the 1890 position (Figure 1.30). East of Sauchar Point the foreshore and dunes are part of the Firth of Forth Site of Special Scientific Interest.

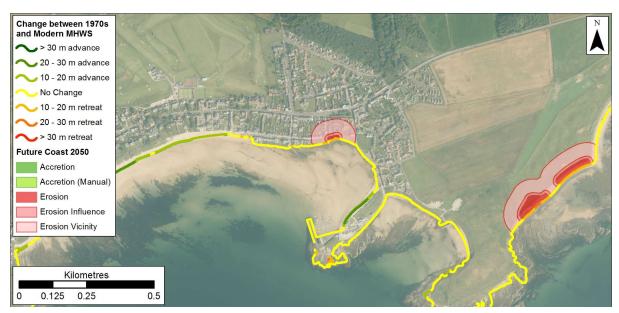
Figure 1.31: Possible future coastline position in 2050 based on rates between 1970 and Modern MHWS data at Earlsferry. Getmapping are our current providers of Scotland-wide digital aerial imagery© Getmapping plc.

Future Vulnerability: The Vulnerability Assessment used the current erosion and accretion rates and projects them forward to 2050. The erosion of over 400 m of linear coast to the east of Elie affects beach and dune land with no built assets located in the area (Figure 1.31). However, the vulnerability of the urban area within Elie at The Terrace and Stenton Row places 15 properties at risk as well as the roadways leading south from the High Street.
